EXHIBIT P

Degradation of polypropylene in the human eye: A sem-study

W.L. JONGEBLOED1 and J.F.G. WORST2

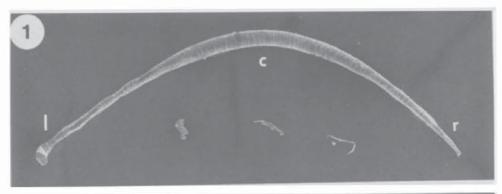
The polypropylene suture which had been in the human eye for $6\frac{1}{2}$ years as fixation suture for an IOL is shown at low magnification in Figure 1. The left end (l) and the right end (r) of the suture show a considerable decrease in suture diameter in comparison with the central part (c). The right end had spontaneously broken, while the left end was cut off to free it from the surrounding tissue.

Figure 1. Polypropylene suture which remained for $6\frac{1}{2}$ years in a human eye as a fixation suture; 1 = cut-off end, diameter appr. $100 \, \mu\text{m}$; r = spontaneously broken off end, diameter appr. $60 \, \mu\text{m}$; c = central part, not in direct contact with tissue, diameter $200 \, \mu\text{m}$. Magn. $20 \times$.

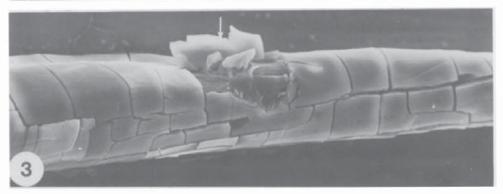
Figures 2 and 3 represent parts of the left side of the suture, cracks perpendicular to the longitudinal axis of the suture are visible. Lumps of the surface layer are nearly detached or are already missing (arrows). Note also the irregularity of the diameter of the suture in both pictures.

Figure 2. Part of left side of suture of Figure 1, showing cracks in surface layer and missing part of surface layer (arrows); note irregular diameter. Magn. 225 ×.

Figure 3. Part of left side of suture of Figure 1, showing cracks in surface layer and nearly detached lump of surface layer (arrow); note somewhat twisted shape of suture. Magn. $325 \times$.

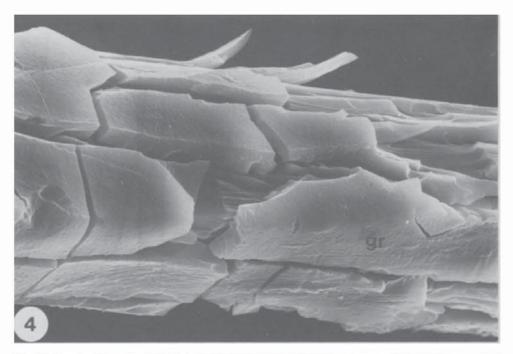
Figures 4 and 5 also represent parts of the left side of the used suture of Figure 1. The cracking of the surface layer is very obvious in Figure 4; almost the complete surface layer has been split off from the underlying layer. The outer surface of the lumps is covered with a thin layer of probably organic material with a slightly granular appearance (Figure 4). Closer to the central part of the suture (the part which was not in direct contact with the tissue) the disintegration of the polypropylene appears to be considerably less extensive. Figure 5 represents a part of the suture left of the centre, the cracks in the surface layer are already present and the diameter decreases towards the left side of the suture.

Figure 4. Part of left side of suture of Figure 1 showing completely disintegrated surface layer, large lumps nearly detached. Magn. $1000 \times$.

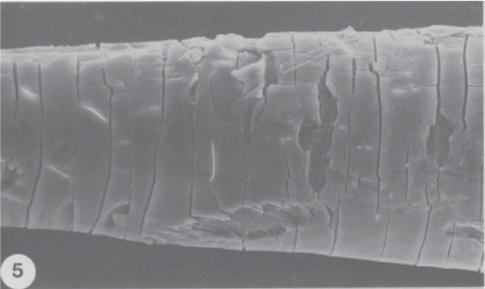
Figure 5. Part of left side of suture of Figure 1, close to central part of suture. Surface less attacked; note decreasing diameter towards left side. Magn. $300 \times$.

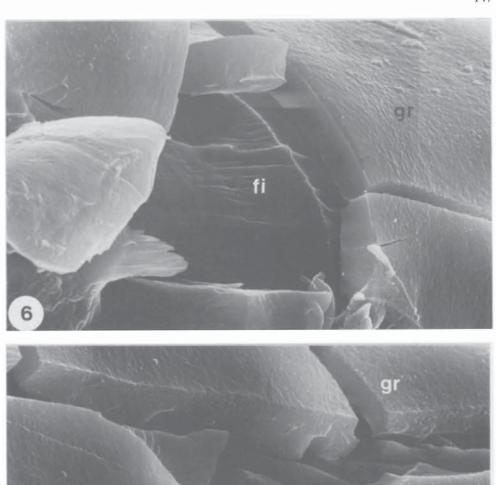
Figures 6 and 7 represent details of Figures 3 and 4 respectively, showing the subsurface layer after splitting off of the lumps of the surface layer. The subsurface layer shows a fibrillar character and the splitting off

of the surface layer is clearly observable. The outside of the lumps of the surface layer is covered with a thin layer of organic material with a slightly granular appearance.

Figure 7. Detail of Figure 4 showing splitting of surface layer from underlying layer with fibrillar appearance (fi); lumps covered with somewhat granular material (gr). Magn. 2000 ×.

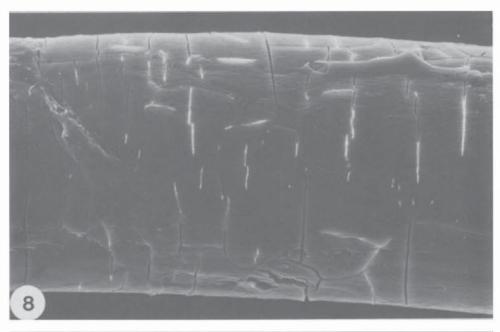
Figure 8 represents the central part of the suture, some cracks in the surface are already visible and some deposition of material. The diameter

still has its original value of 200 μ m. Figures 9–13 represent sections of the right side of the suture of Figure 1.

Figure 8. Central part of suture of Figure 1, which was not in contact with tissue. Some cracking of surface layer present; diameter $200\,\mu\text{m}$. Magn. $300\,\times$.

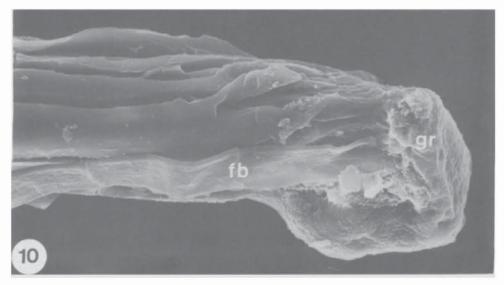
Figure 9 shows the irregular diameter and the splitting off of parts of the surface layer, at low magnification.

Figure 9. Part of right side of suture of Figure 1 at low magnification showing irregular diameter and cracking of surface layer. Magn. $120\times$.

Figure 10. Spontaneously broken end of suture of Figure 1 showing granular deposit (gr) and fibre-like material (fb) at the tip. Magn. $600 \times$.

The spontaneously broken-off end of the suture, the actual reason for removal from the eye, is shown in Figure 10. The end of the surface is covered with slightly granular material and rather long strands of fibrillar material.

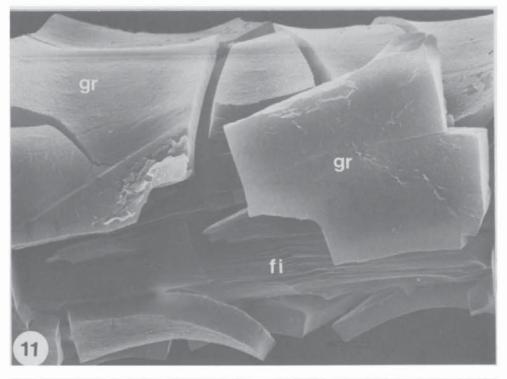
Figure 11 shows the destruction of the polypropylene in a rather dramatic way; the complete surface layer has broken into pieces, exposing the subsurface layer. The outside layer is covered with some deposits, mainly of a granular nature.

Figure 11. Part of right side of suture of Figure 1 showing almost complete degradation of surface layer, large lumps have detached exposing subsurface layer with fibrillar character (fi). Note granular deposit on lumps (gr). Magn. $975 \times$.

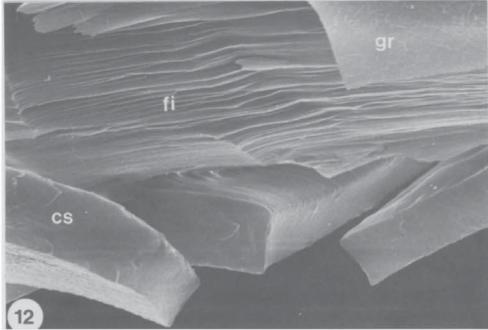
The subsurface layer is observable in more detail in Figure 12 (detail of Figure 11); the fibrillar character of this layer is clearly visible, while the splitting of the surface layer is noticeable, particularly at the cross-sections of the split-off lumps in the lower part of the picture.

Figure 12. Detail of Figure 11 showing subsurface layer (fi) and split-off lumps of surface layer in more detail (cs). Magn. $2500 \times$.

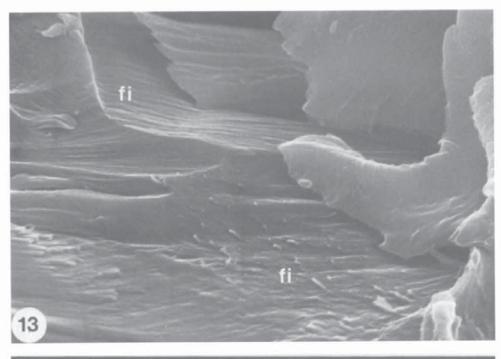
The fibrillar character of the subsurface layer, and the irregular splitting of the surface layer from the underlying layer as the result of a chemical change in the surface layer, are shown in more detail in Figure 13.

Figure 13. High magnification of subsurface layer after detachment of surface layer; note irregular splitting effect due to chemical change in polypropylene. Fibrillar character (fi) of subsurface layer clearly observable. Magn. $5000 \times$.

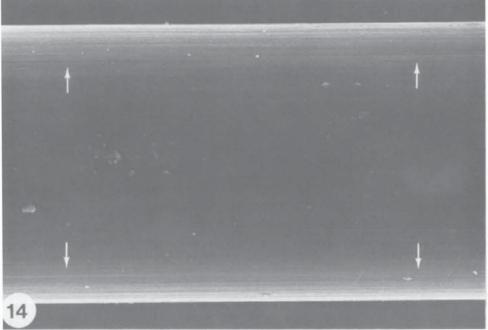
In a virgin piece of surgical polypropylene, taken from an intact package, none of the phenomena described above are observable (Figure 14). The diameter is $200 \,\mu\text{m}$ and only thin grooves due to the manufacturing process are visible running along a very smooth surface (arrows).

Figure 14. Virgin piece of polypropylene from a surgical packet, prepared for SEM in exactly the same way as the suture of Figure 1, showing no degradation at all; note manufacturing grooves (arrows). Magn. $300 \times$.
